DATE: August 18, 2008

SUBJECT: SITE VISIT AND GEOPHYSICAL SURVEY: PRE-ASSESSMENT OF PUBLIC WORKS (OBRAS PUBLICAS) SITE, GUANICA, PUERTO RICO. WORK ASSIGNMENT #0-358 - TRIP REPORT

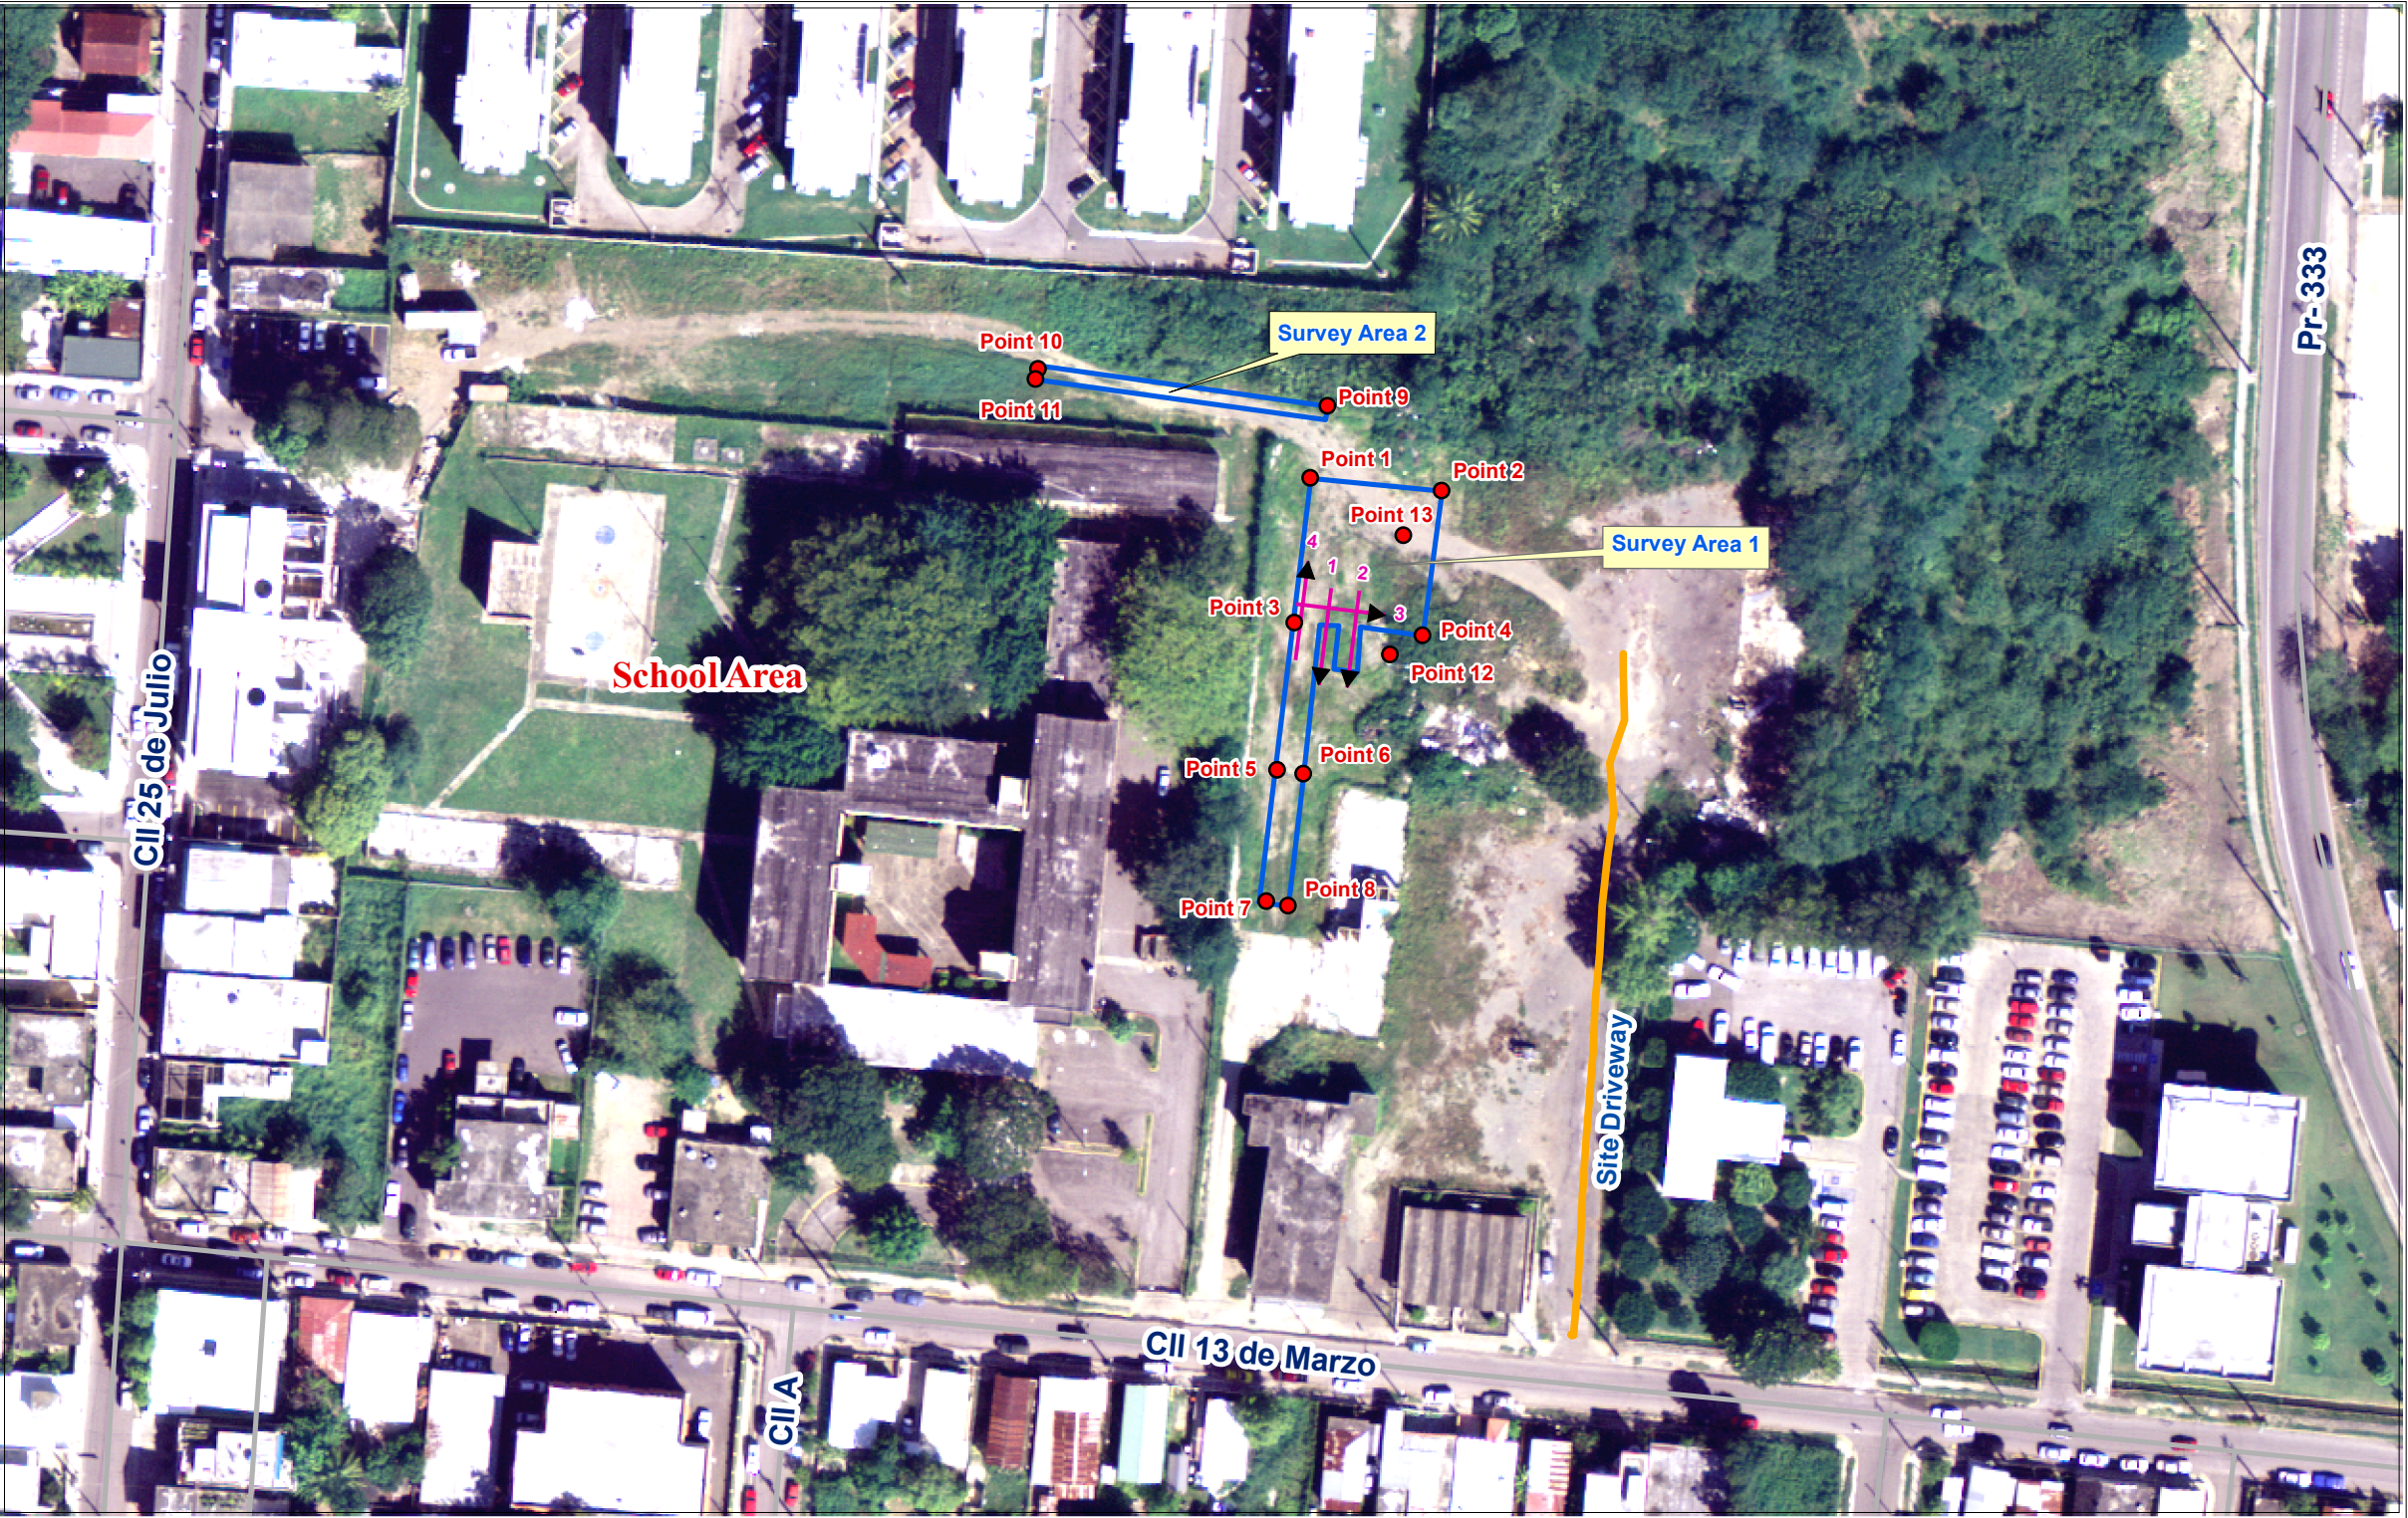
Figure 1
Site Overview
Public Works (Obras Publicas)
Guanica, Puerto Rico
August 2008

This two to five-acre site, located within the residential area of Guanica, is expected to be developed into a shopping center. Although there are no buildings on the site, there are several concrete slabs. Along with the concrete slabs, the site has cleared and grassy areas, mounds of debris, and areas that are heavily vegetated with shrubs and trees. Drums and other debris are rumored to be buried at this site. A school is adjacent to the site along the western perimeter. Figure 1 provides an overview of the site and shows the two areas (Survey Areas 1 and 2) for which the preliminary geophysical survey was performed.

Figure 3 shows four profiles collected with the GPR system within Survey Area 1. Figure 1 indicates the location of the four profiles where Profile 1, Profile 2 and Profile 4 were collected in a north-south direction, and Profile 3 was

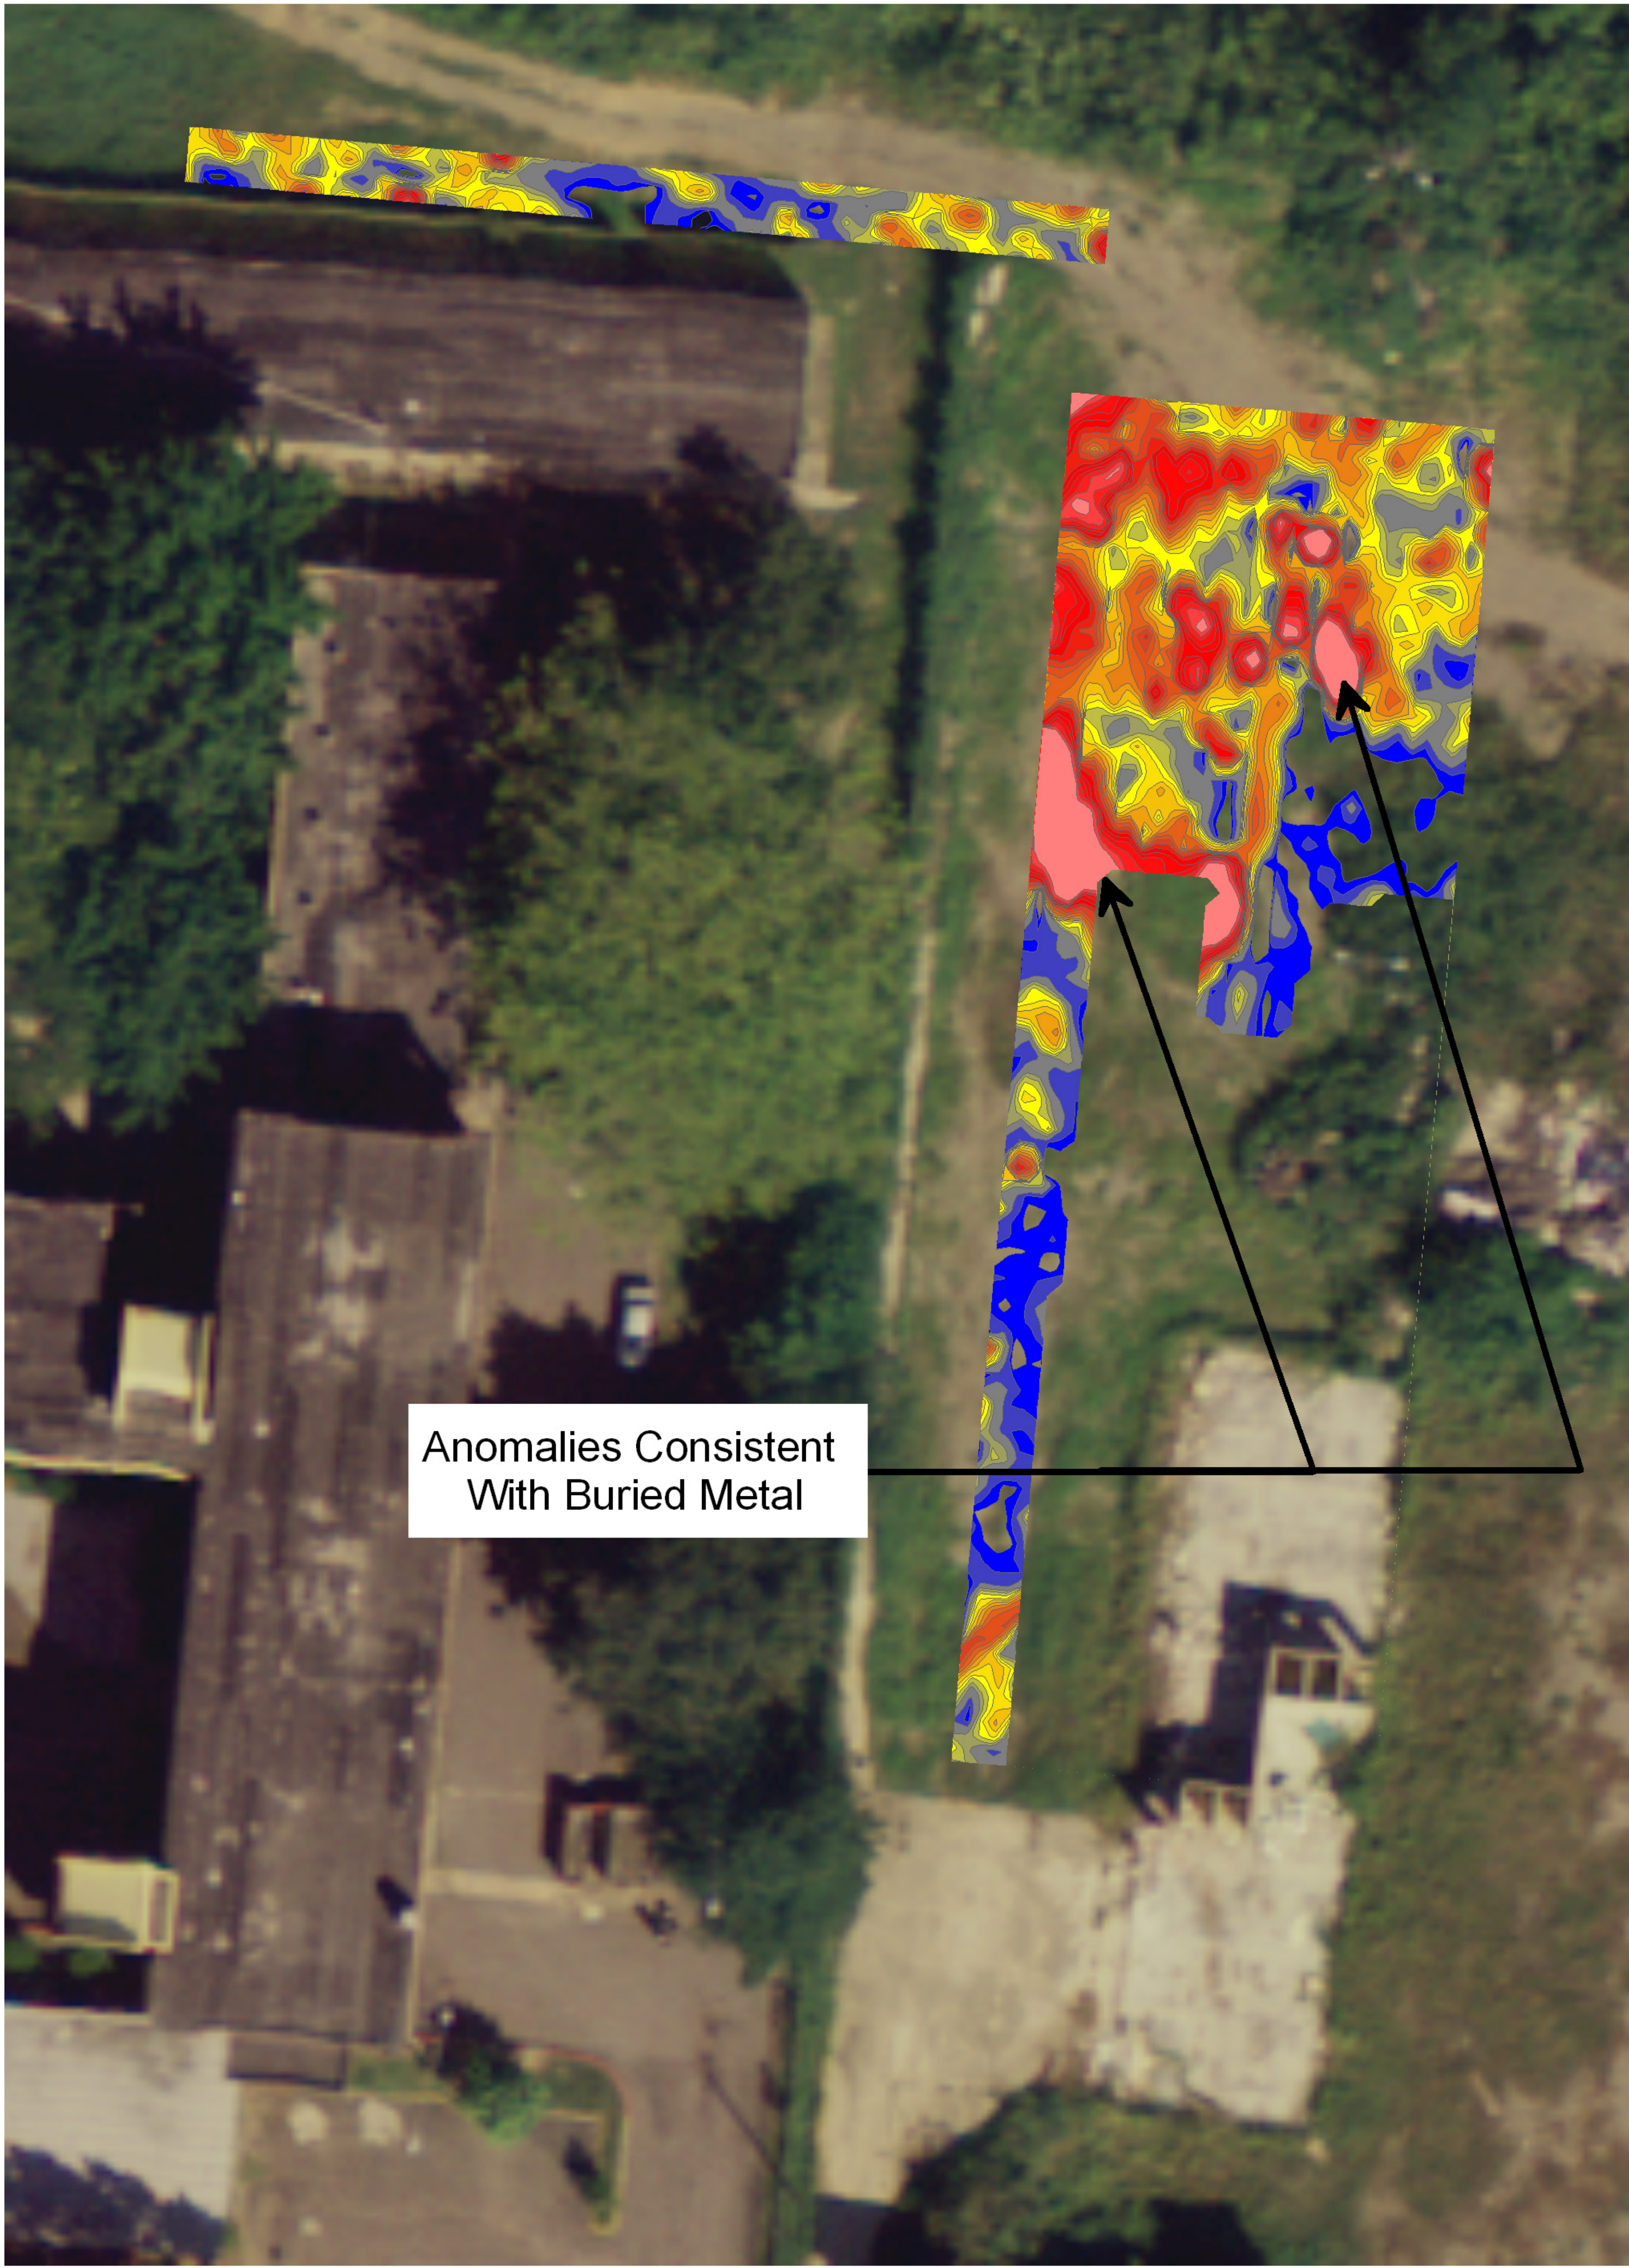
Figure 2
Peak EM-61 Differential Response Map
Guanica Public Works
Guanica, Puerto Rico

Figure 2 provides the EM61 differential response for Survey Areas 1 and 2. Survey Area 1 has an irregular shape due to the accessibility limitations of the survey equipment resulting from high vegetation. The narrow area along the southern end of Survey Area 1 had a low response indicating little to no buried metal. On the southern end of this area, there was an EM-61 response consistent with a buried utility line. The northern end of Survey Area 1, which is somewhat rectangular, has a higher differential response indicating significant levels of buried metal. Two areas, indicated on Figure 2, had a response consistent with a high concentration of buried metal. These two anomalies are potentially buried drums.

Survey Area 2 had responses on both ends that are indicative of small to medium concentrations of metal that are unlikely to represent large items such as drums. The center of this survey area had very low responses indicative of little to no buried metal present (Figure 2).

collected in an east-west direction. These four profiles are located where the largest anomalies were observed from the EM-61 responses provided in Figure 2. The anomalous areas identified in Figure 3 are chaotic regions in the profiles from the radar waves reflecting off surfaces that are not parallel to the surface or to each other. Profile 2 and Profile 3 appear to have disturbed areas in the surface above the anomalies. These anomalies are also large enough to be caused by metal objects several feet long.

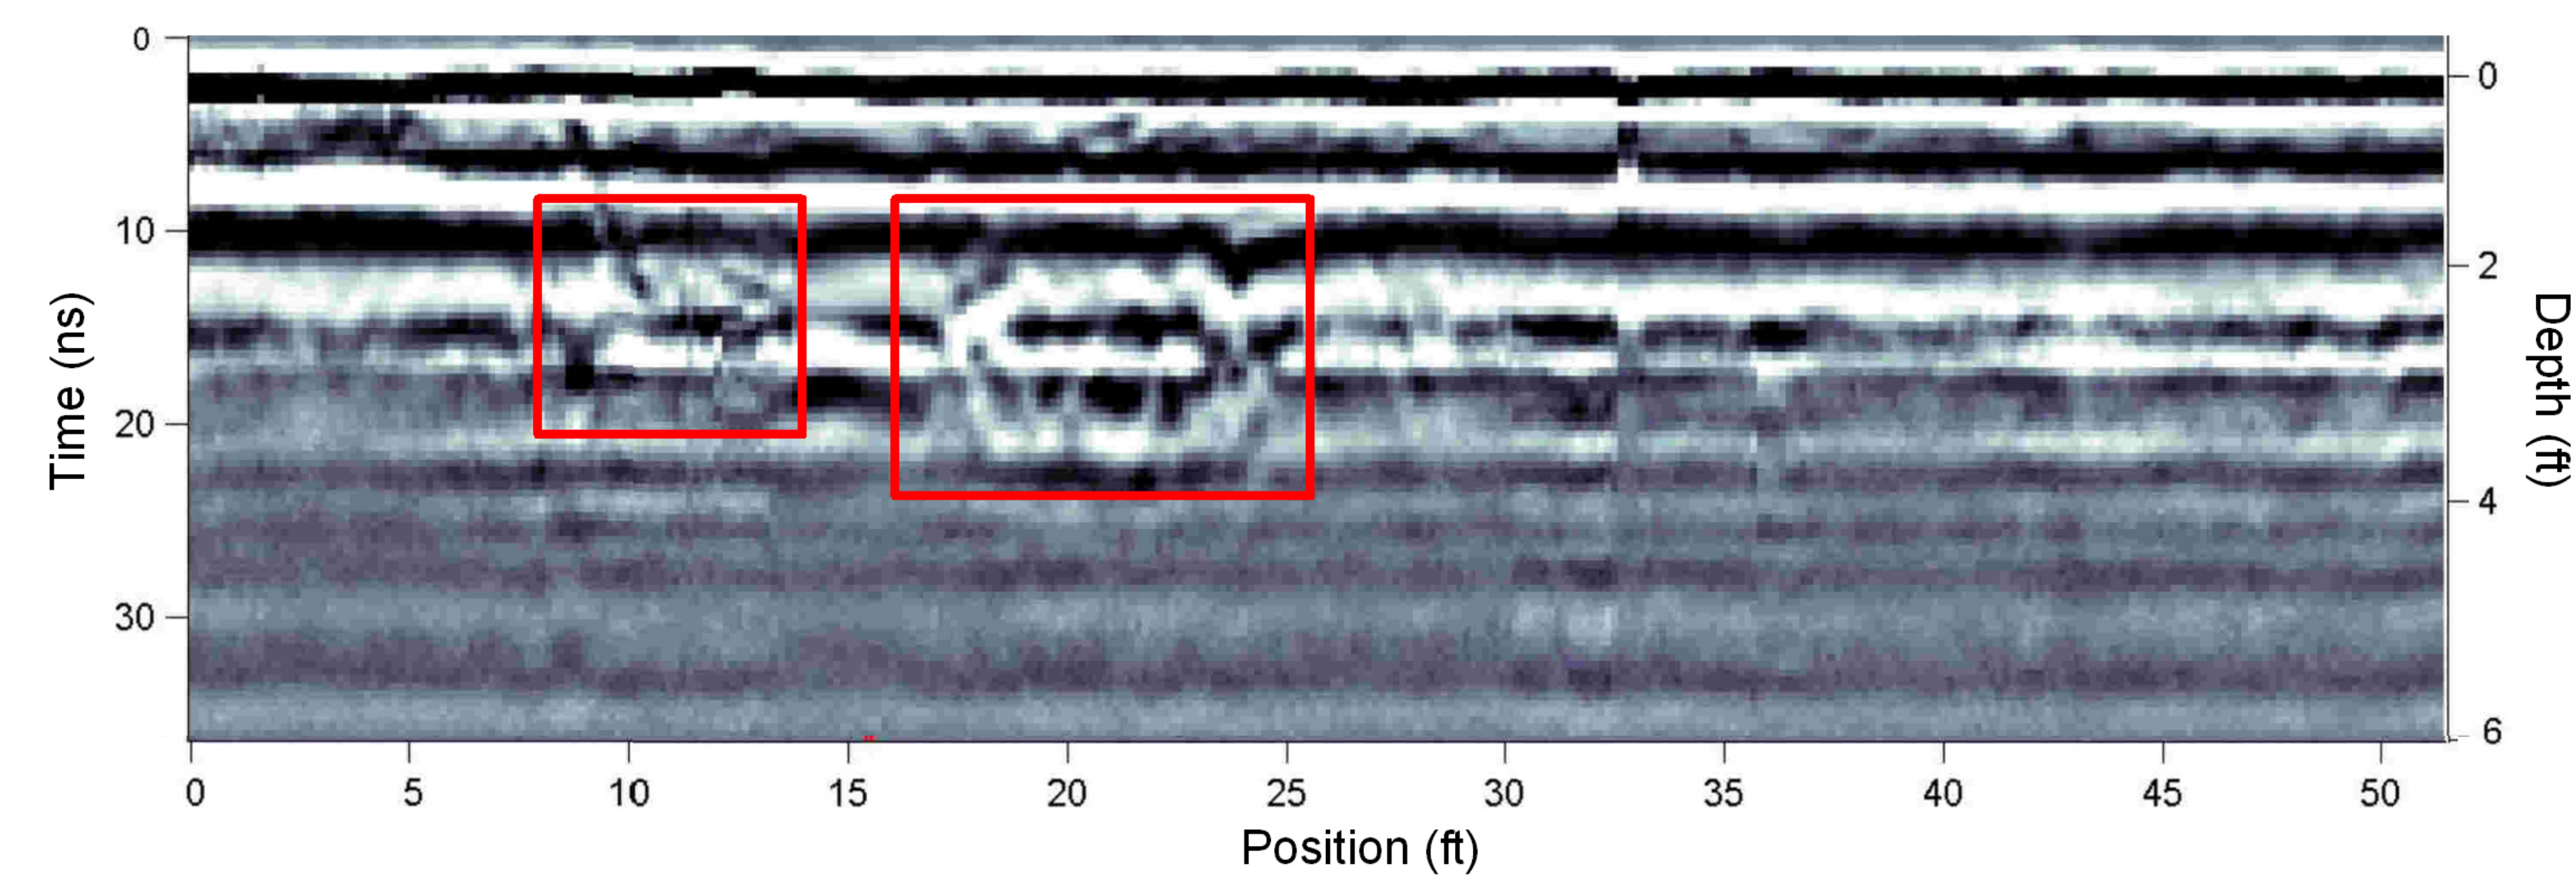
Profile 1

Anomalous reflections possibly
from buried metal
